## **REPORT ON TRAIN DERAILMENT IN PITTSBURGH TUNNEL WEDNESDAY OCTOBER 10, 2001**

**By Thomas Edward Fox**

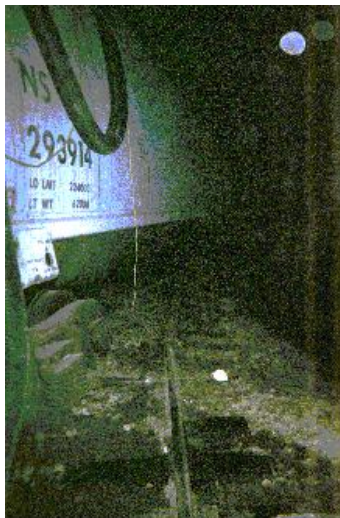
*Derailed Cars in Tunnel*

Twelve derailed hopper cars were left positioned in an “accordion” manner down the tracks in the tunnel and touching the tunnel walls. At least three of the cars were lying on their sides against the walls of the tunnel. Railroad officials decided that all cars should have the grain corn on the cars unloaded before any attempt would be made to right them or pull them out of the tunnel. This tactic of reducing the weight of the cars would hopefully prevent severe damage to the cars, the track bed, and the walls of the tunnel.

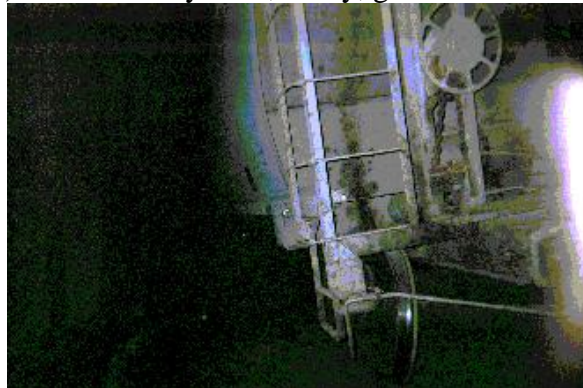
### *Derailed Cars in Tunnel*

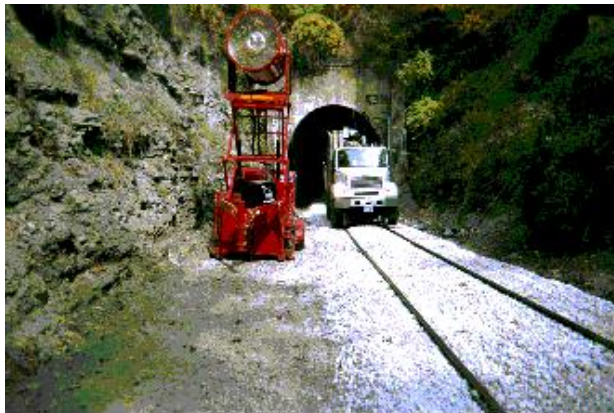
*MVU Positioned in Front of Tunnel Portal*

The MVU was then positioned approximately ninety (90) feet from the south portal of the tunnel. It was placed to the side of the tracks allowing the heavy equipment and other train cars to pass by on the track bed.

The MVU blower was elevated to about 12 feet above the track bed and turned approximately twenty degrees toward the portal. It was tilted downward toward the opening at approximately a fifteen-degree angle. An “air lock seal” was formed around the “mouth” of the tunnel, which prevented the pressurized air in the tunnel from escaping through the entry portal. (A note was made that had there been no space for the MVU along the side of the tracks - solid rock face for example, a “platform” could have been built on the ravine wall and the MVU could have been aimed downward from this greater angle to ventilate the tunnel opening.)

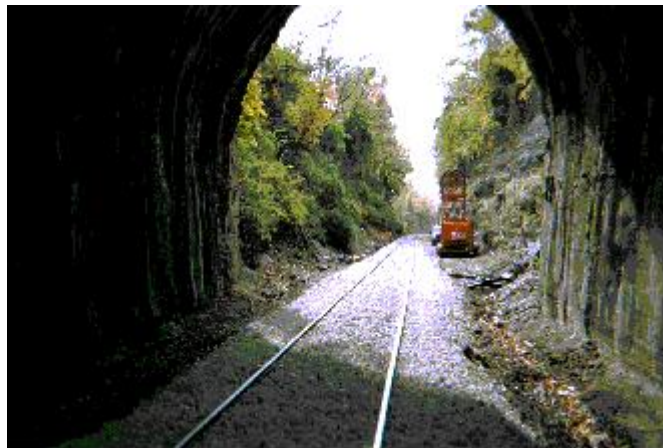
*View From Inside Tunnel of MVU*

At the same 8' height and center of the track bed but at 40' into the tunnel, the wind speed was measured at 11mph. Measurements at 60' into the tunnel were recorded at 8.5mph, at 80' wind speed was 7mph, and at 100' the wind velocity was 5.6mph.

The initial readings of air movement at, and in, the tunnel were zero velocity. When the MVU was cranked and the engine accelerated to approximately 2400 RPM, the air velocity in the portal was measured at 18.1mph. This measurement was taken from the center of the track bed and eight feet above the ground (as high as the anemometer could be held in the hand above the head).
