# Boeing 727-200 Aircraft Hydraulic Blower Positive Pressure Ventilation Tests Conducted at Ontario International Airport

## Test Objectives

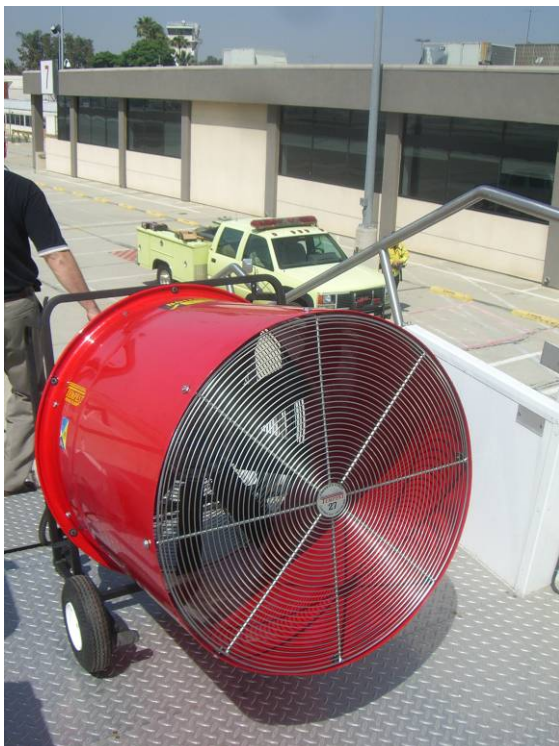
The 27-Inch Extended Shroud Blower

On June 22, 2006, positive pressure ventilation (PPV) tests were conducted at Ontario International Airport. The scope of the test was two fold. First was to test two new Tempest hydraulic blowers for operation and performance. One is a 24" standard shroud and the other is a 27" with an extended 27" shroud. The test was conducted using an Accessair Stair Truck to provide a platform for the blowers.

On the final test we wanted to see what effect of moving the stair truck back from the aircraft would have with the 27" extended shroud blower. John Thompson felt that we would get more entrainment of air and do quicker ventilation than being closer to the door. ASO Pierce and Captain Allomong explained that in actual aircraft firefighting the inflatable escape slide has to be deflated or released from the door before a stair truck can be parked at the aircraft door. In order to do this, a ladder must be placed on the escape chute and a fire fighter has to climb up to get into the doorway, then turn around and cut the slide away or release it. If the blower worked, this would enhance the

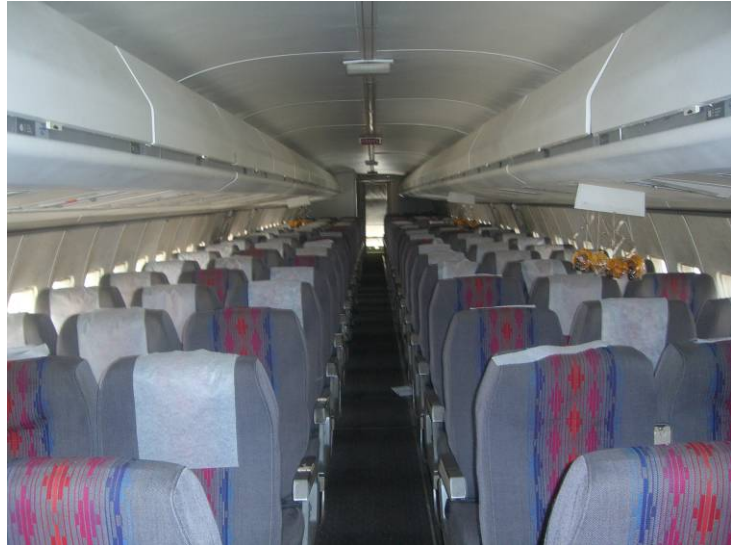
**Normal view from flight deck to rear of aircraft**

front of the nose of the aircraft at 12:00 oriented towards the tail so we could see an exterior view of the smoke exiting from any and all openings. The other video camera was set up in the doorway to the cockpit looking down the aircraft aisle to the rear galley to record the movement of the smoke as it exited. The rear exit to the stairway was closed. The first smoke test was done only opening the rear side doors (R2 and L2) to get a bench mark of time and PPV performance. All newer commercial passenger aircraft only have side fuselage doors and over wing hatches. Aircraft are no longer being produced with stairs at the rear of aircraft. There were two smoke machines used; one at the front of the aircraft and one at the rear. Captain Allomong wore an SCBA to avoid the smoke and would open the rear doors (L2 and R2) once he saw that the smoke totally obscured visibility. John Thompson and Luis Cadena would enter the cabin and open the over wing hatches upon Danny's signal. The elapsed time for the first test was 1:26 minutes to ventilate the entire aircraft using the standard 24" Blower. When the test was conducted with the 27" extended shroud, the time was 1:22 minutes. Some smoke is being pushed through the rear of the plane though the stairway door. It is almost closed to the cabin to allow for the extension cord that is connected to the smoke generator. Once we had established the bench mark, we then ran tests alternating the blowers while opening two over wing hatches and four doors. On the 24" model with the standard shroud it took 1:15 minutes and on the 27" extended shroud it was 1:12 minutes for smoke removal. We also ran a test of opening a combination of two over wing hatches and four doors and let the prevailing wind ventilate the plane. After over three 3:40 we concluded that the prevailing wind had little effect on ventilation and used the blower to clear the aircraft for more tests.

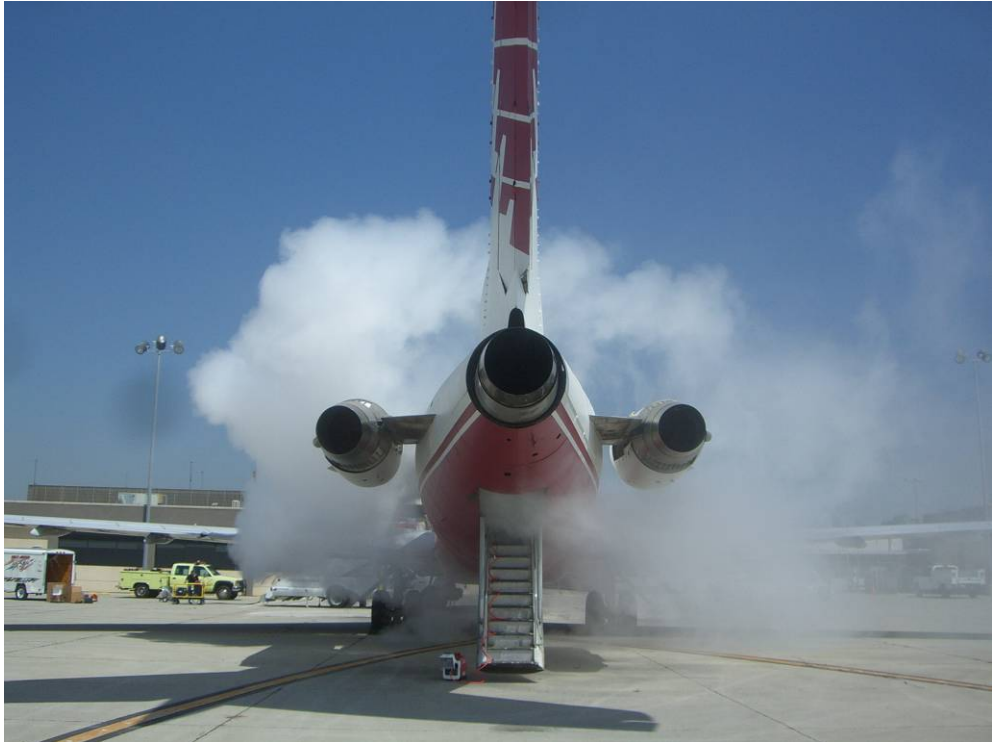
**Smoke ejected with PPV**

environment for the firefighter as well as improving the interior environment of the aircraft. In moving the stair truck back away from the door, we were able to ventilate the aircraft in 53 seconds with two over wing hatches and four doors opened. This was important to both ARFF and passengers/crew for enhancing the environment prior to firefighters entering the aircraft plus aiding the potentially incapacitated victims.

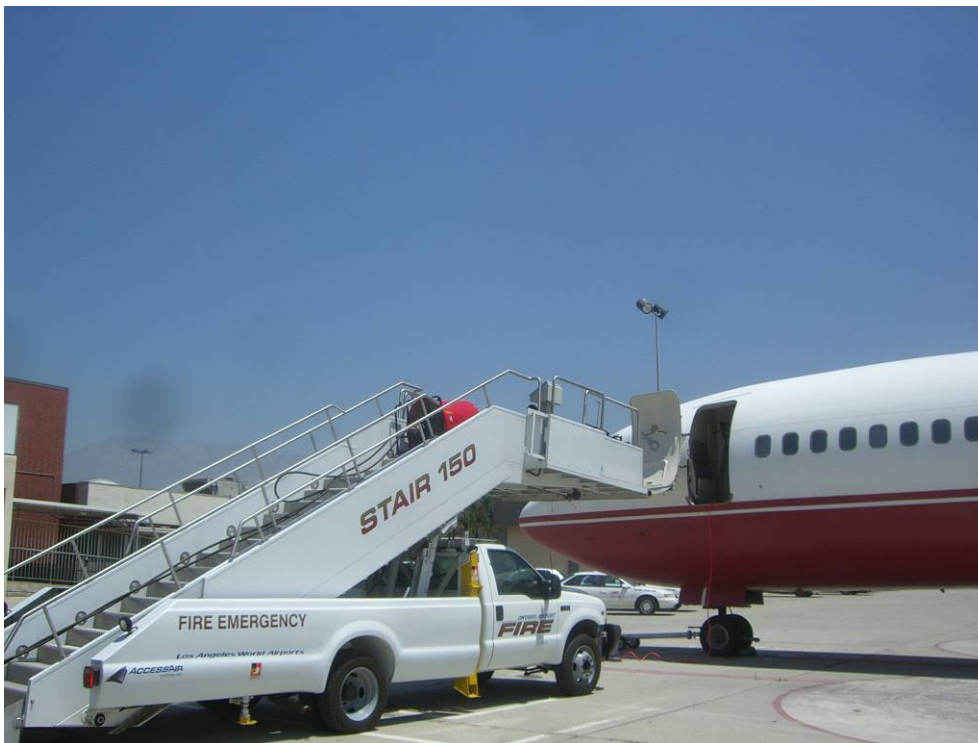
**AIAV backed away from aircraft to simulate a slide deployment.**
